# Manhole Inspection Summary

Manhole # S29SS\_002MH

Insp Date: **8/5/08 9:17 AM**

**Location** Address: **2800 FALLS RD**

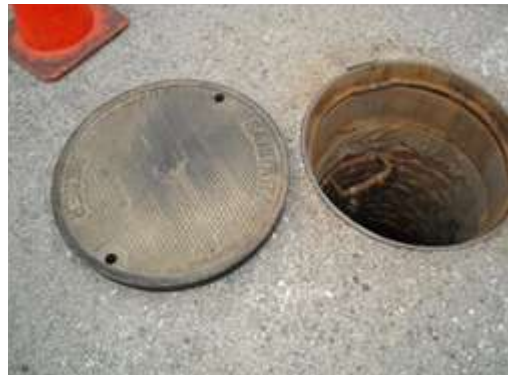
Replaced lid

Metal Frame Adjustment

Caused cover to be stuck.

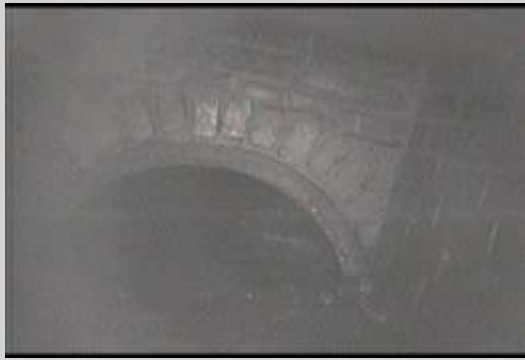
### 27 in. Circular Gravity Sewer Pipe Out @ 12 O'Clock

Pipe Material: **Unknown** ☐ Pipe Lined

Invert Depth: **9.80** (ft.) Flow Characteristics: **Turbulent**

Infiltration: **None** Pipe Seal Cond: **Unknown**

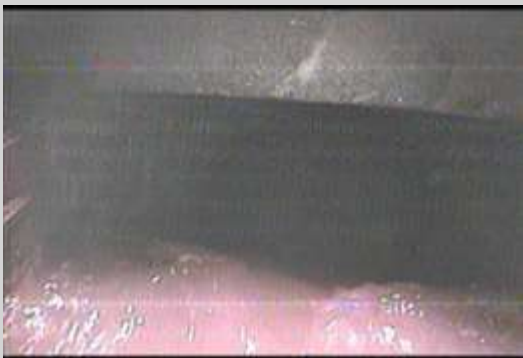
### 21 in. Circular Gravity Sewer

Pipe Material: **Unknown** ☐ Pipe Lined

Infiltration: **None** Pipe Seal Cond: **Unknown**
